Site Accessibility Evaluation

Allmendinger Park
655 Pauline Blvd
Ann Arbor, MI 48104
ADA Only

Inspection Date: 07/11/2022

Report Date: 11/15/2022

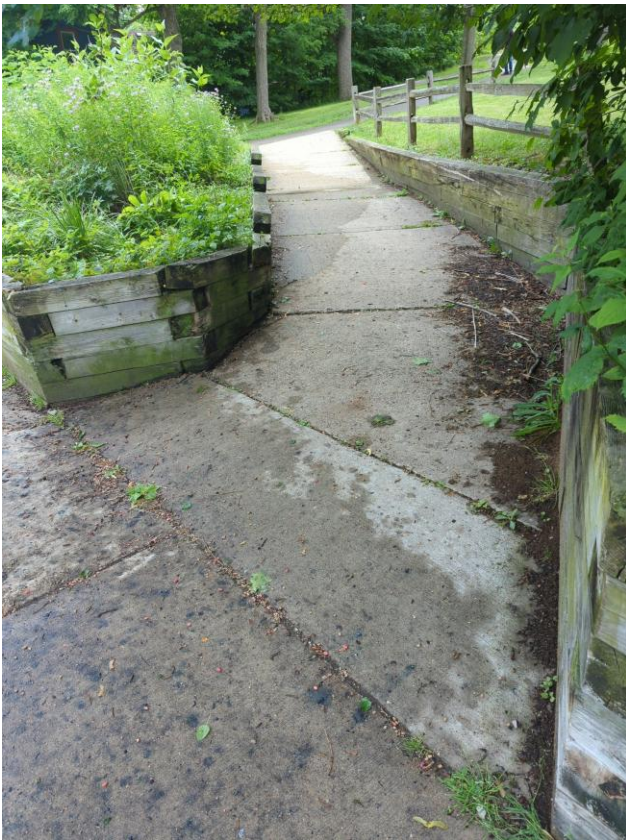
Ramp connecting to public sidewalk has a cross slope of up to 4.3%

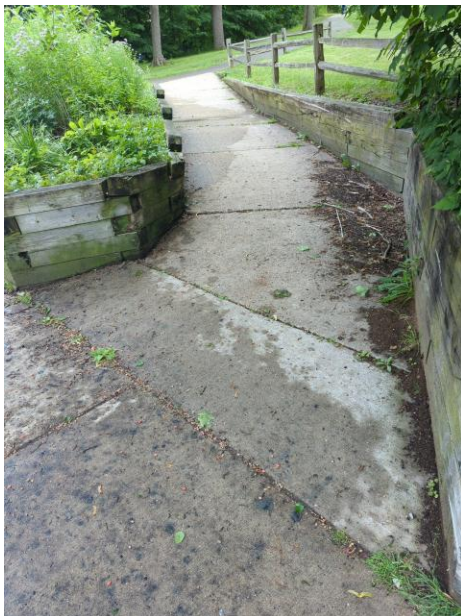
Ramp connecting to public sidewalk does not have handrails

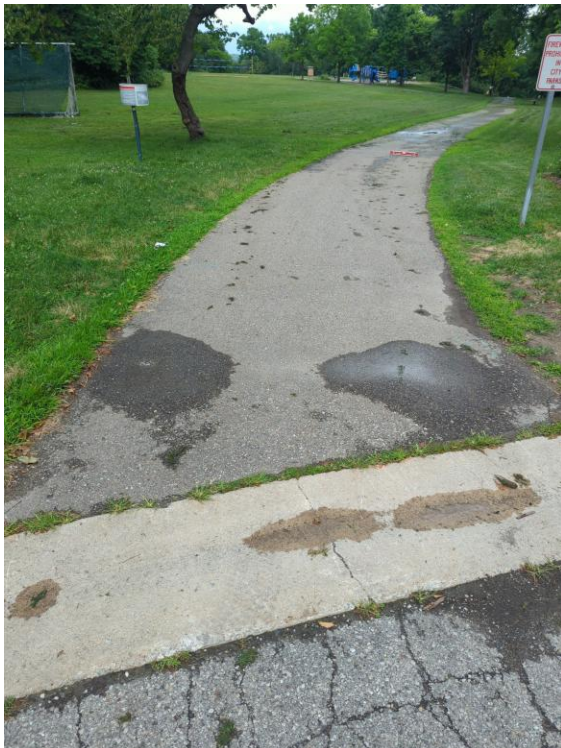
Path from Edgewood Place to park has a cross slope of up to 3.5%

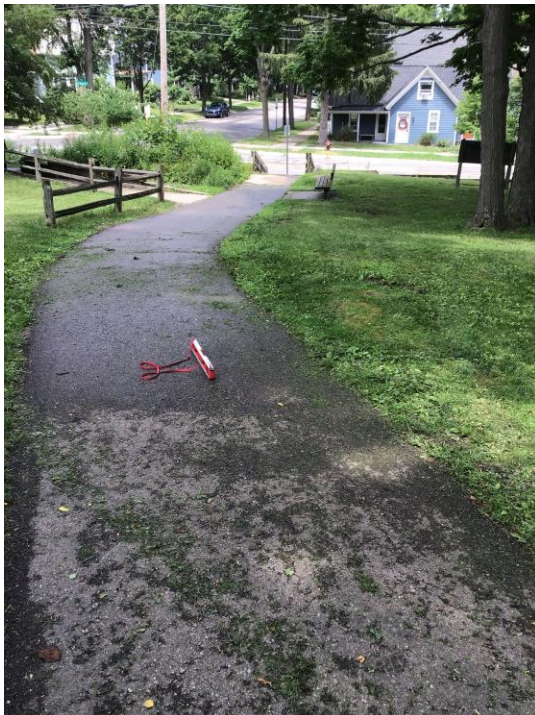
Accessible route from public entrance to park has a running slope of 12%.

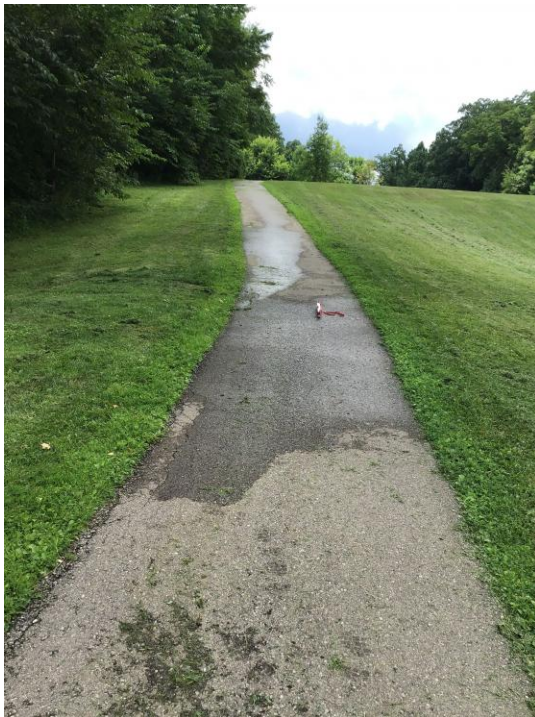
Accessible route adjacent to play area has a running slope of up to 12%.

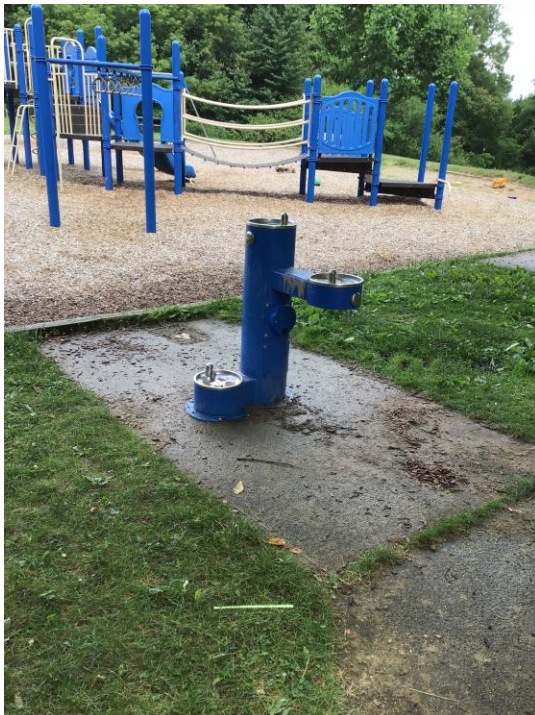
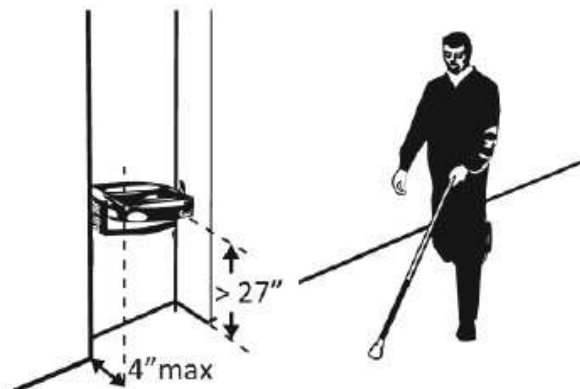
The location of the "low" drinking fountain makes it a protruding object.

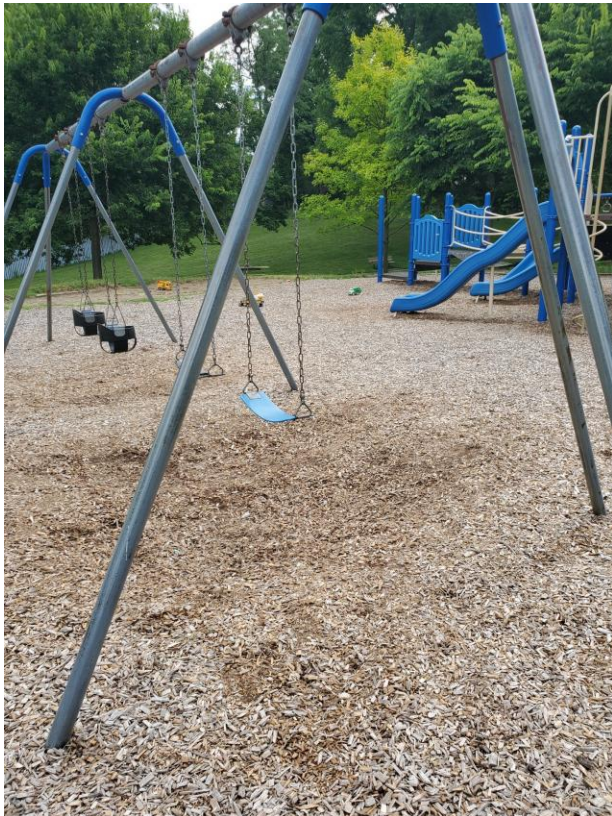
The swing play area ground surface is not compliant; surface is not firm, stable, and slip resistant.

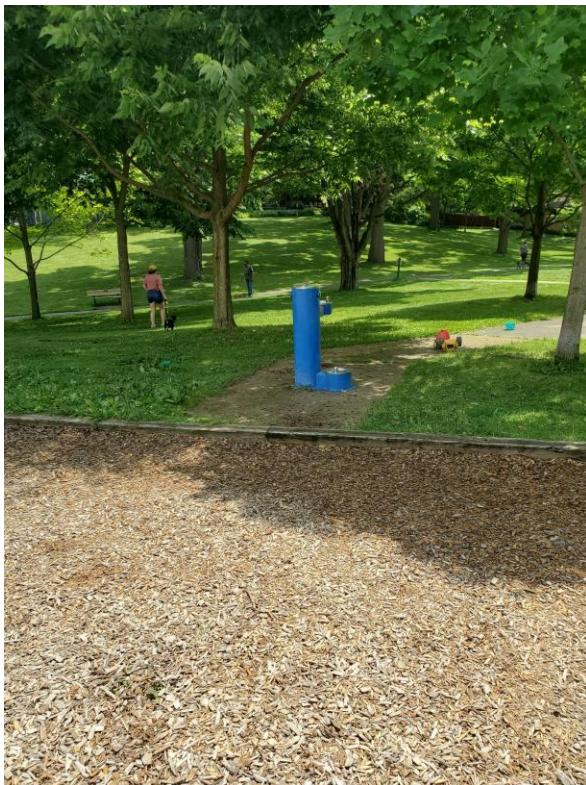
There is no accessible route provided to the play area.

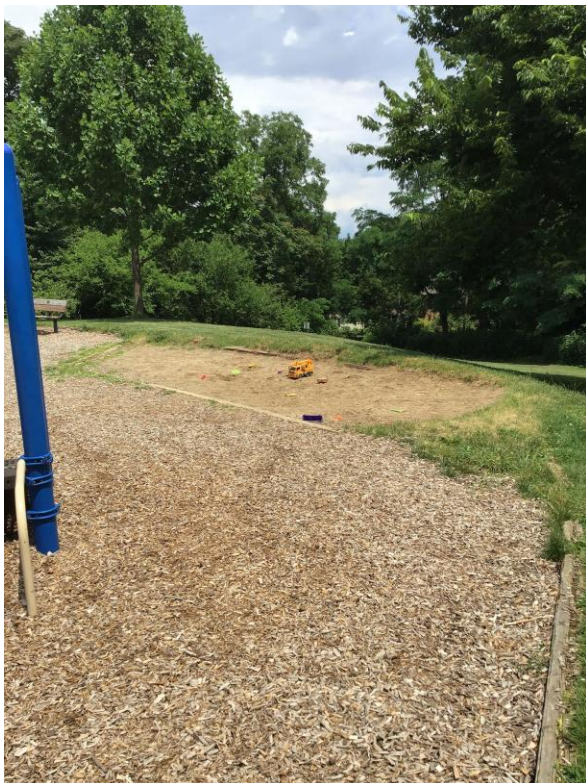
There is no accessible route provided to the sand pit.

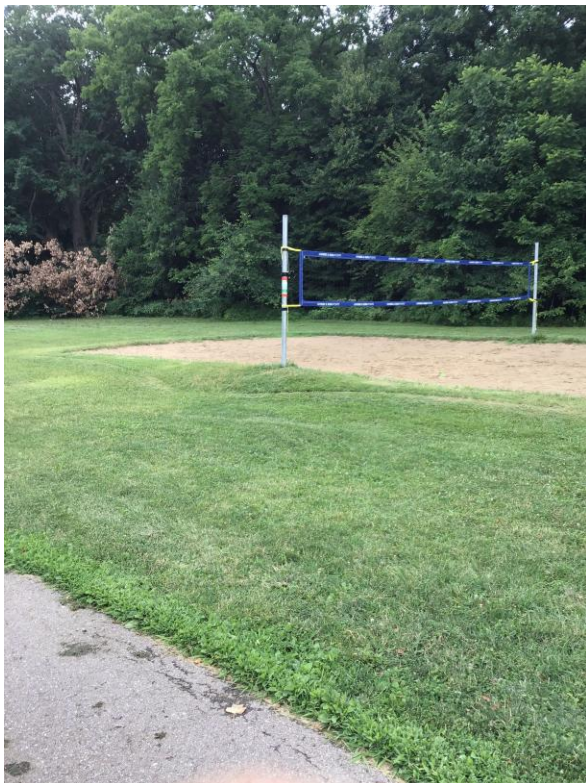
There is no accessible route provided to the sand volleyball court.

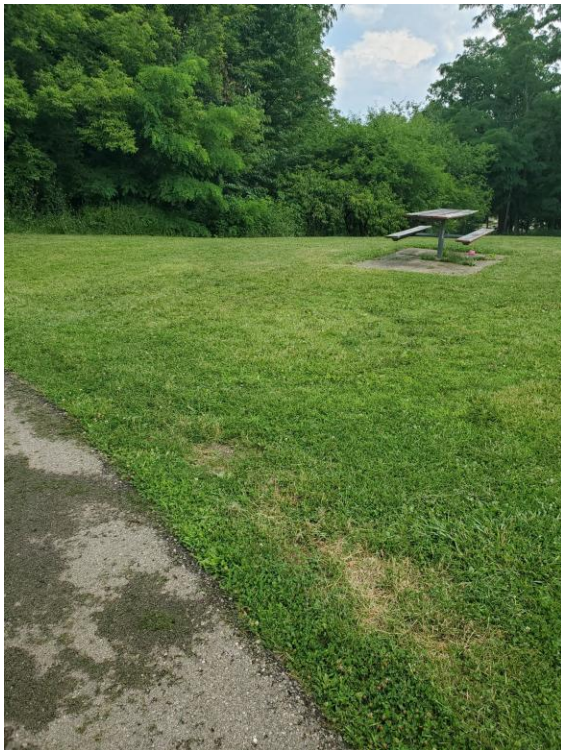
There is no accessible route provided to the picnic table; at least 5% of the picnic tables must be accessible and on an accessible route.
